**SYSTEMS GROUP CHAIRMAN FACTUAL REPORT ADDENDUM FOR
BOEING/AIR FORCE CENTER WING TANK FUEL HEATING STUDY**

A. ACCIDENT: DCA96MA070

Airplane : Boeing 747- 131, N93119
Operated as Trans World Airlines (TWA) Flight 800

TITLE CENTER WING TANK FUEL HEATING STUDY
(VOLUME I OF IV)

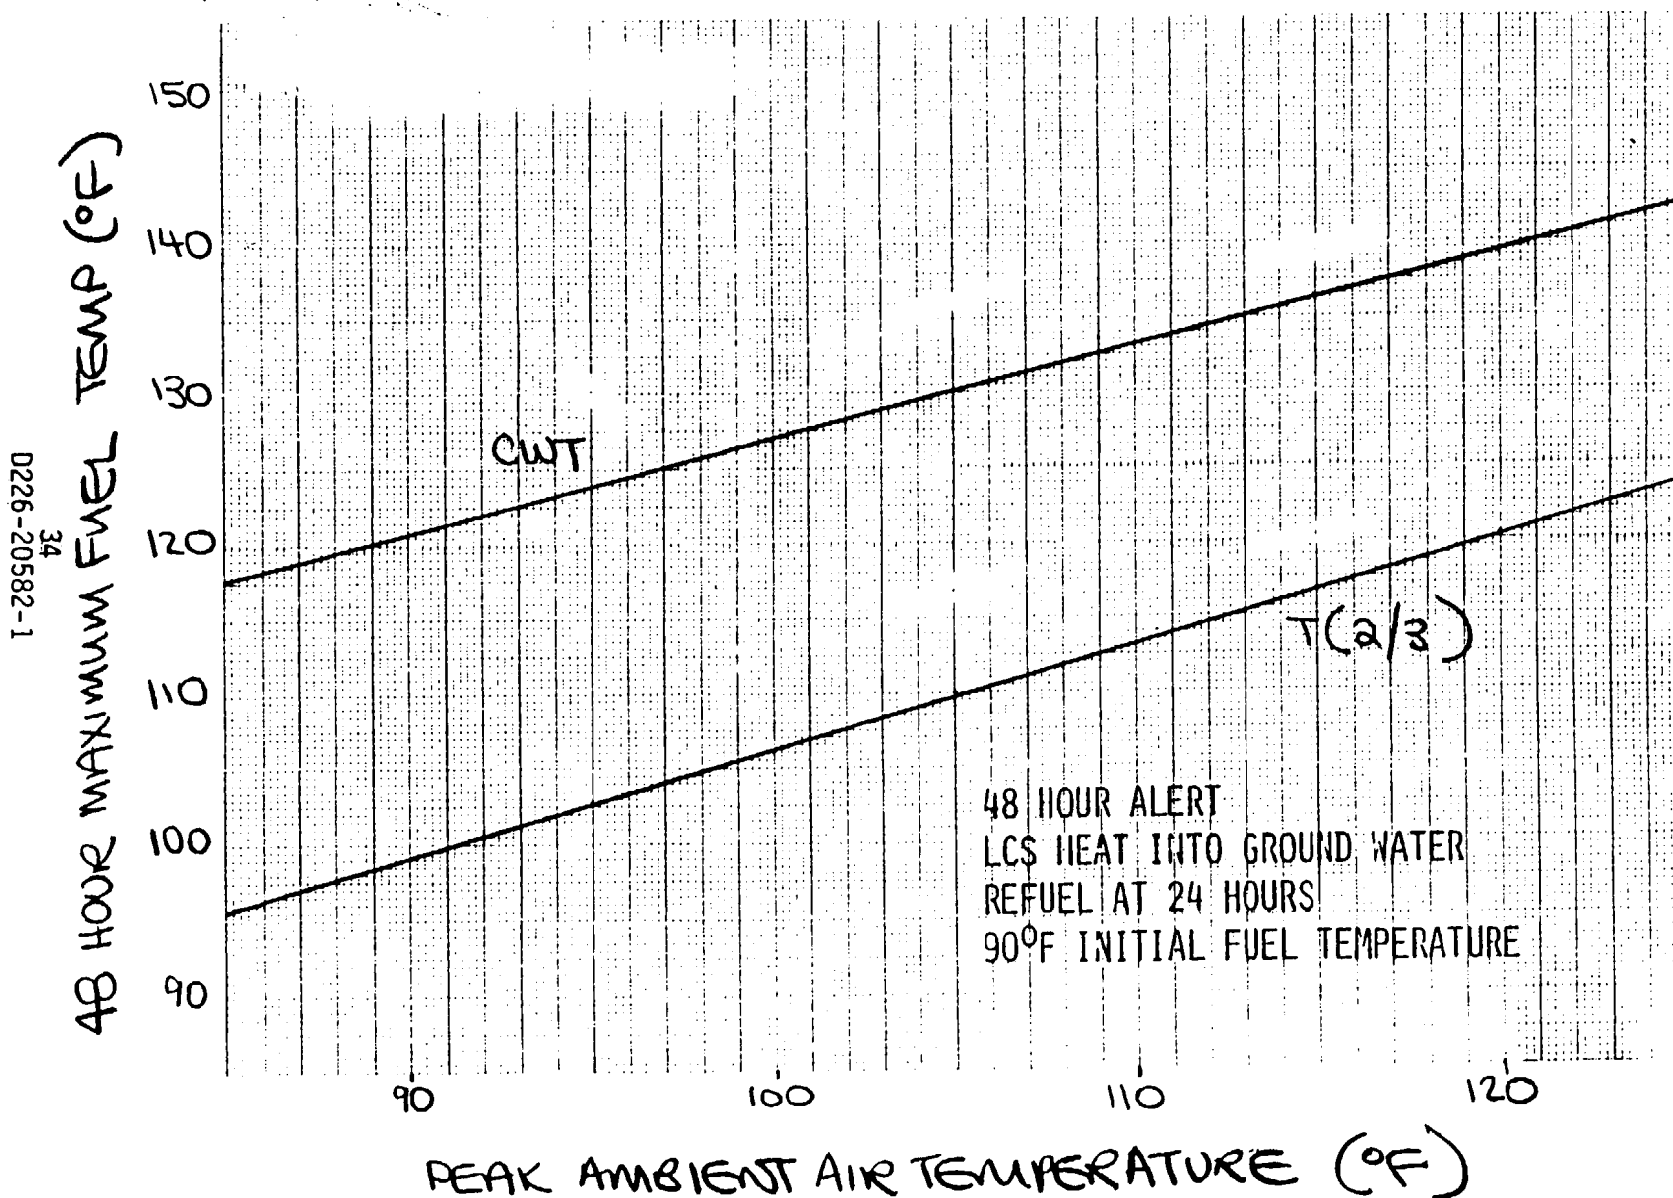
FIGURE 2.9 MAXIMUM FUEL TEMPERATURE WITH AMBIENT ENVIRONMENT VARIATION

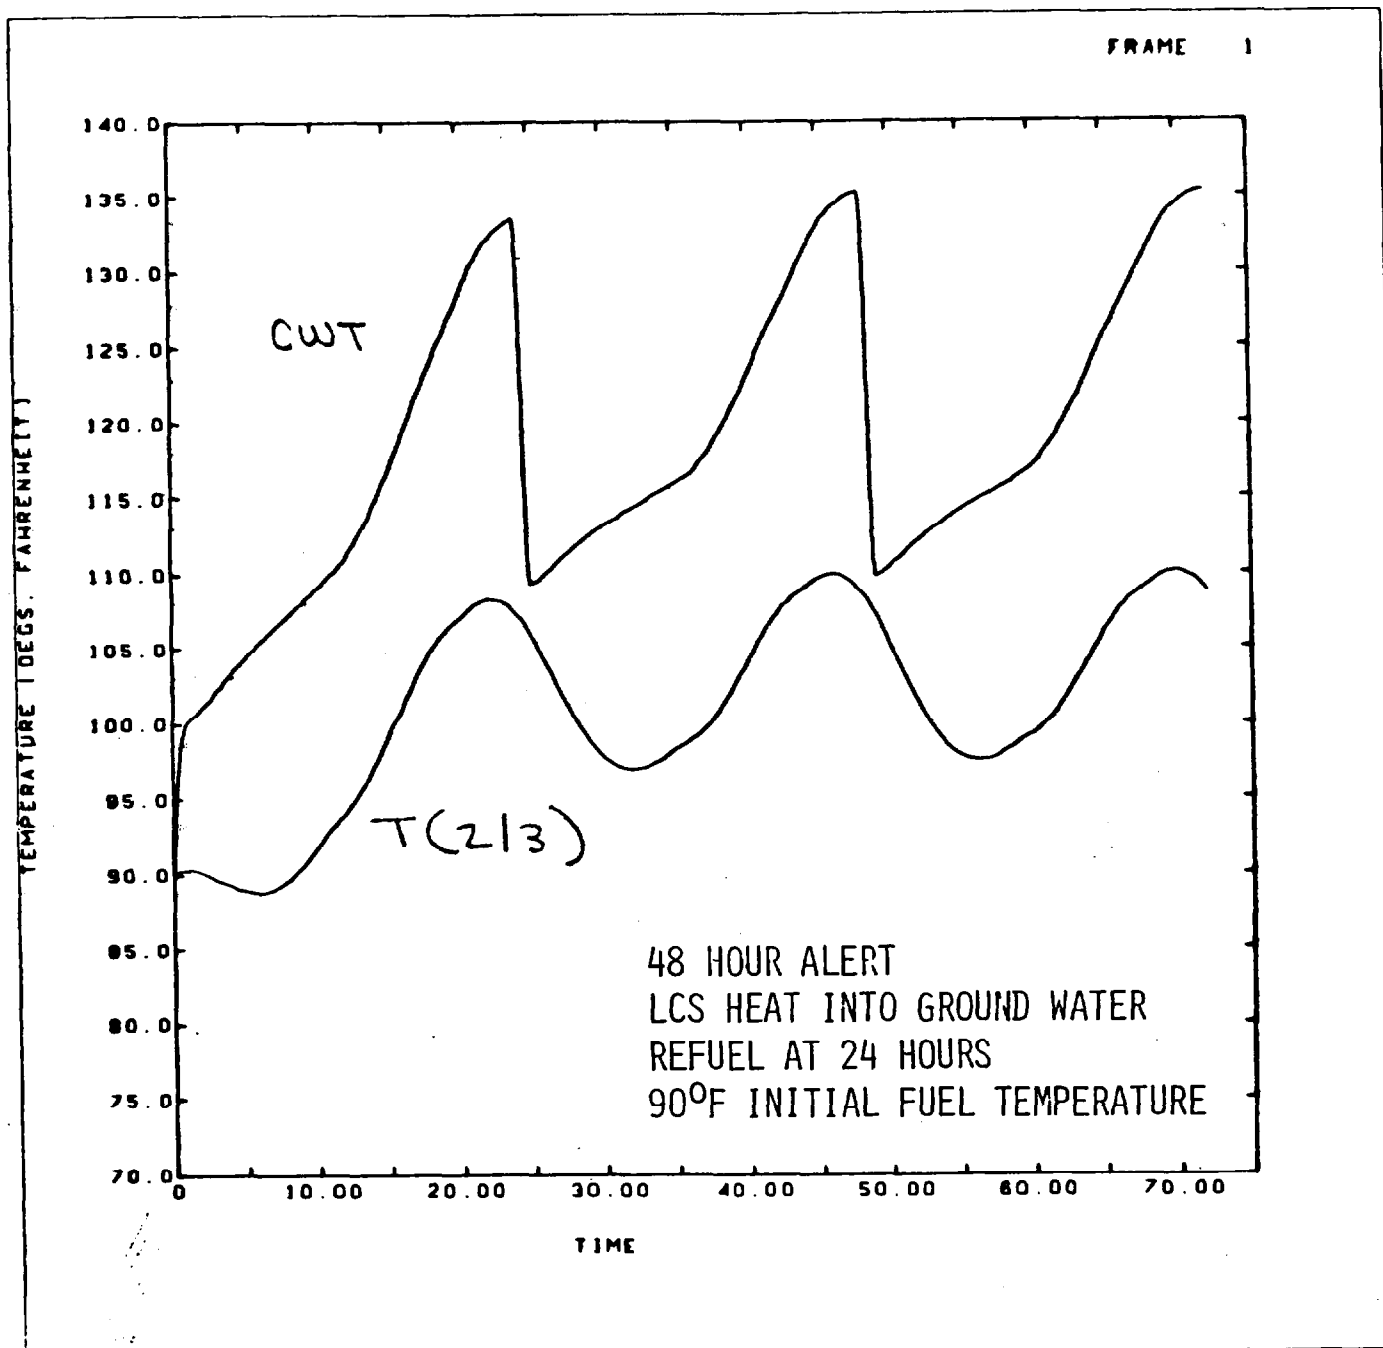
Figure 2.9.1

Fuel Temperature Variation with Time (105°F Peak Air Temperature)

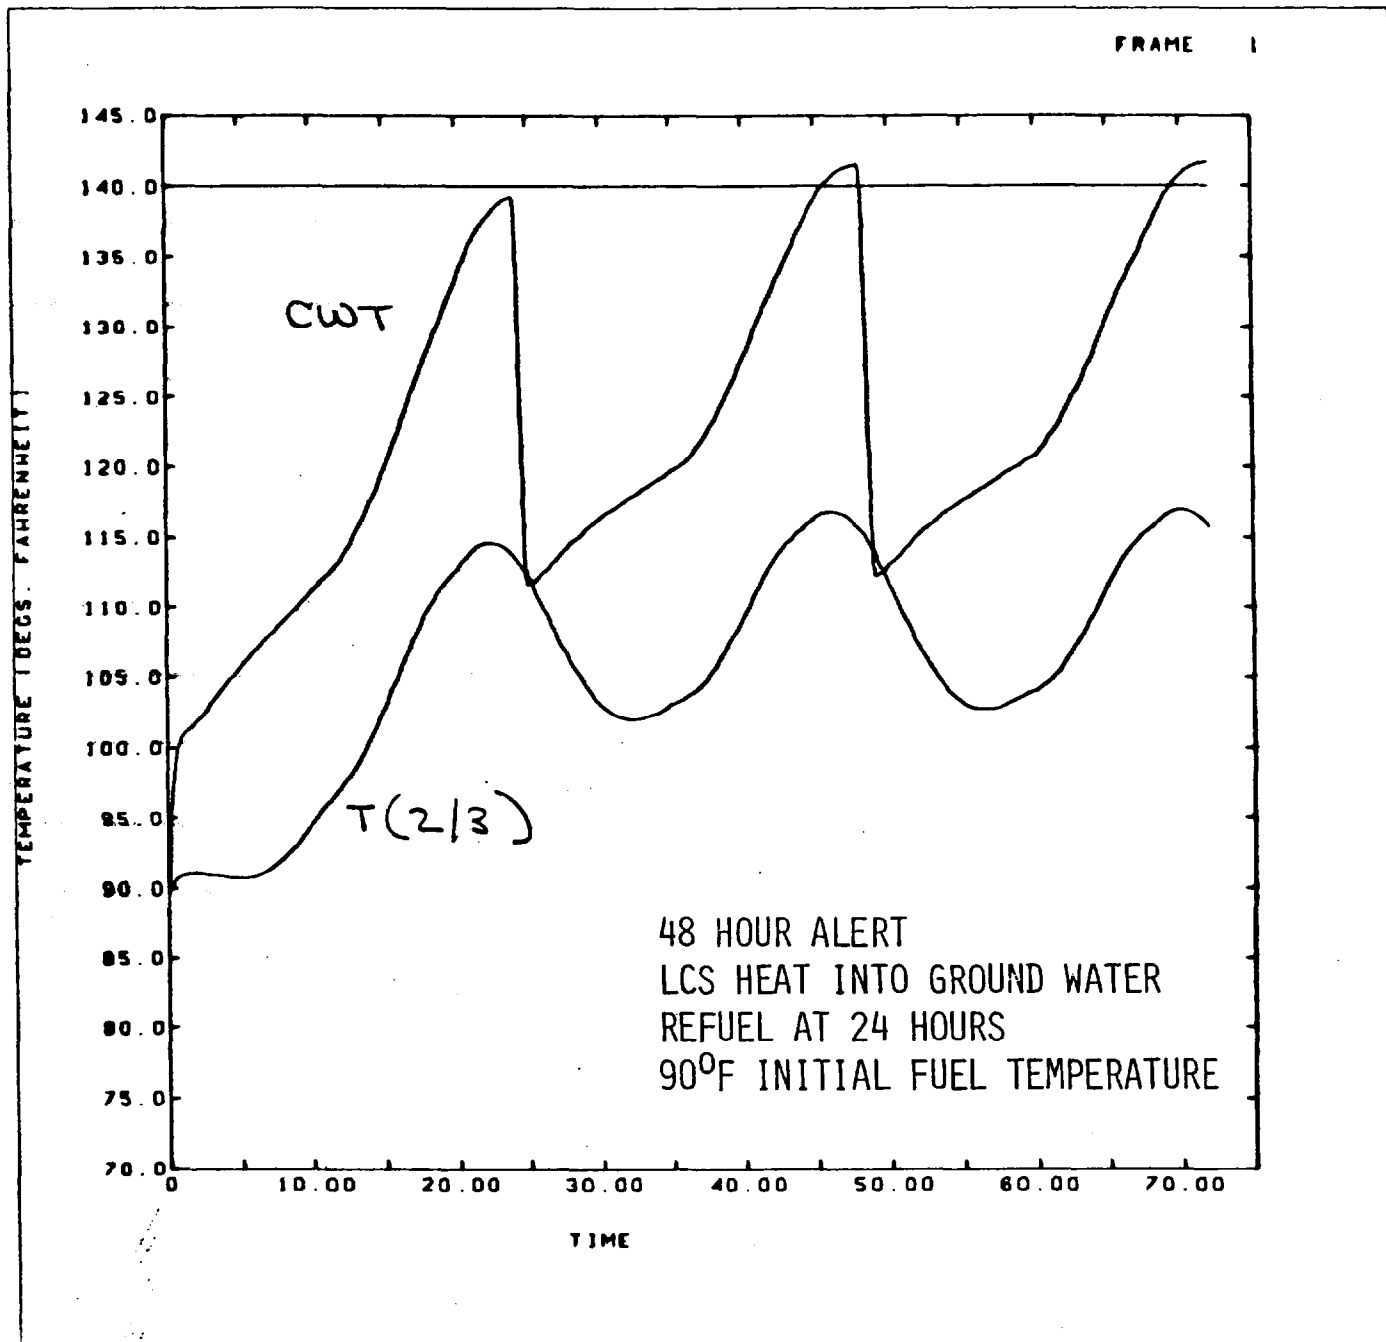
Figure 2.9.2

Fuel Temperature Variation with Time (115°F Peak Air Temperature)

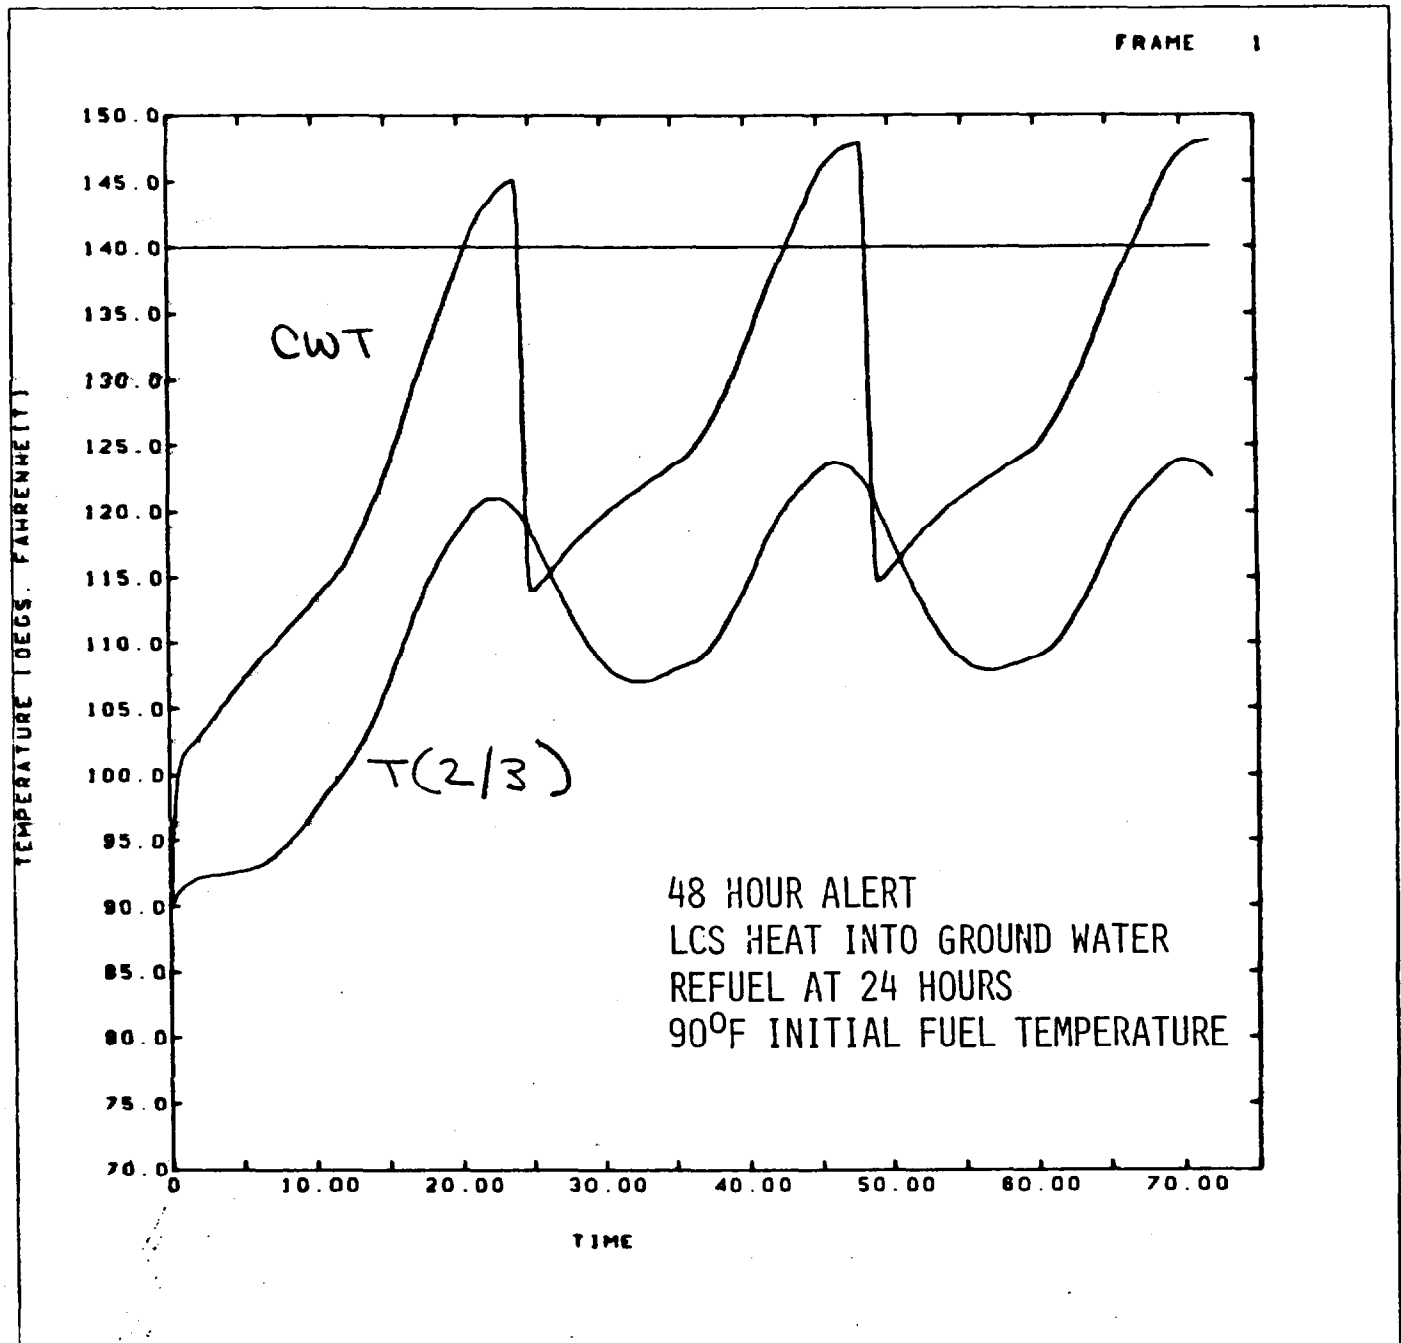
Figure 2.9.3

Fuel Temperature Variation with Time (125°F Peak Air Temperature)

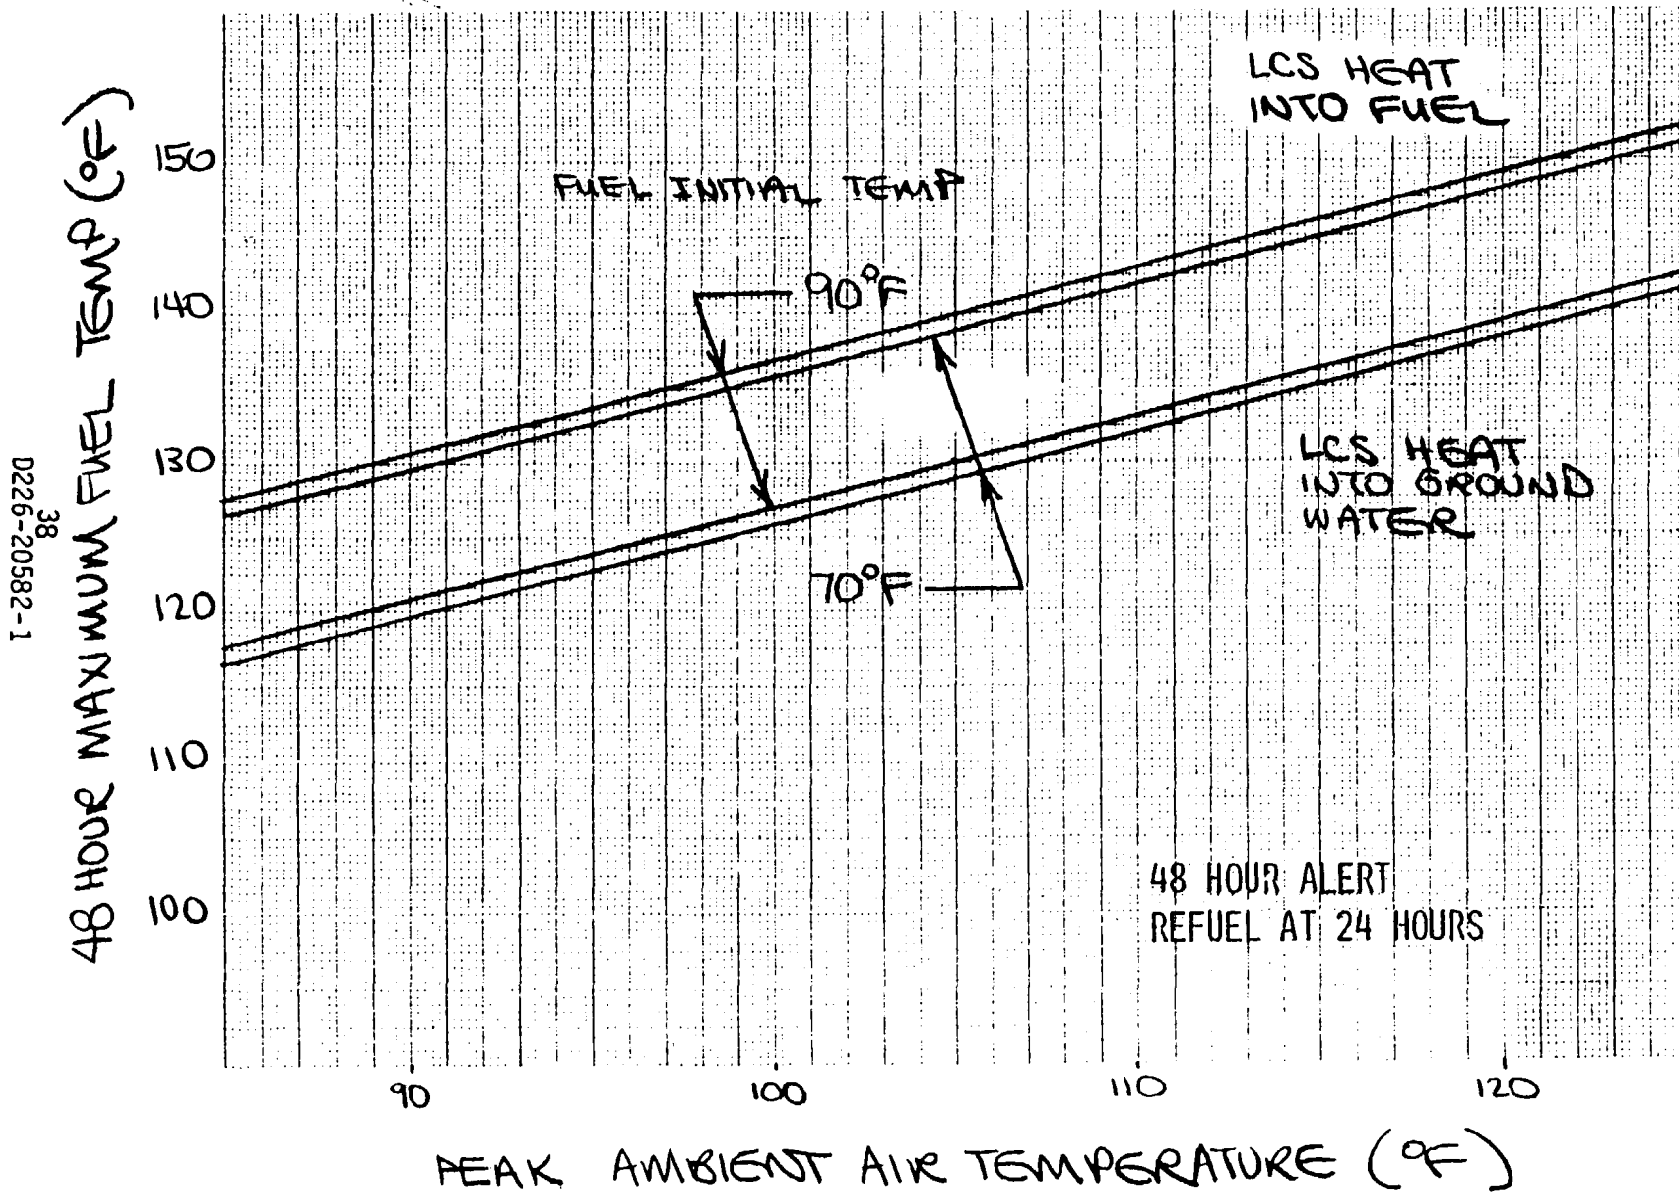
FIGURE 2.10

INITIAL FUEL TEMPERATURE EFFECT CWT

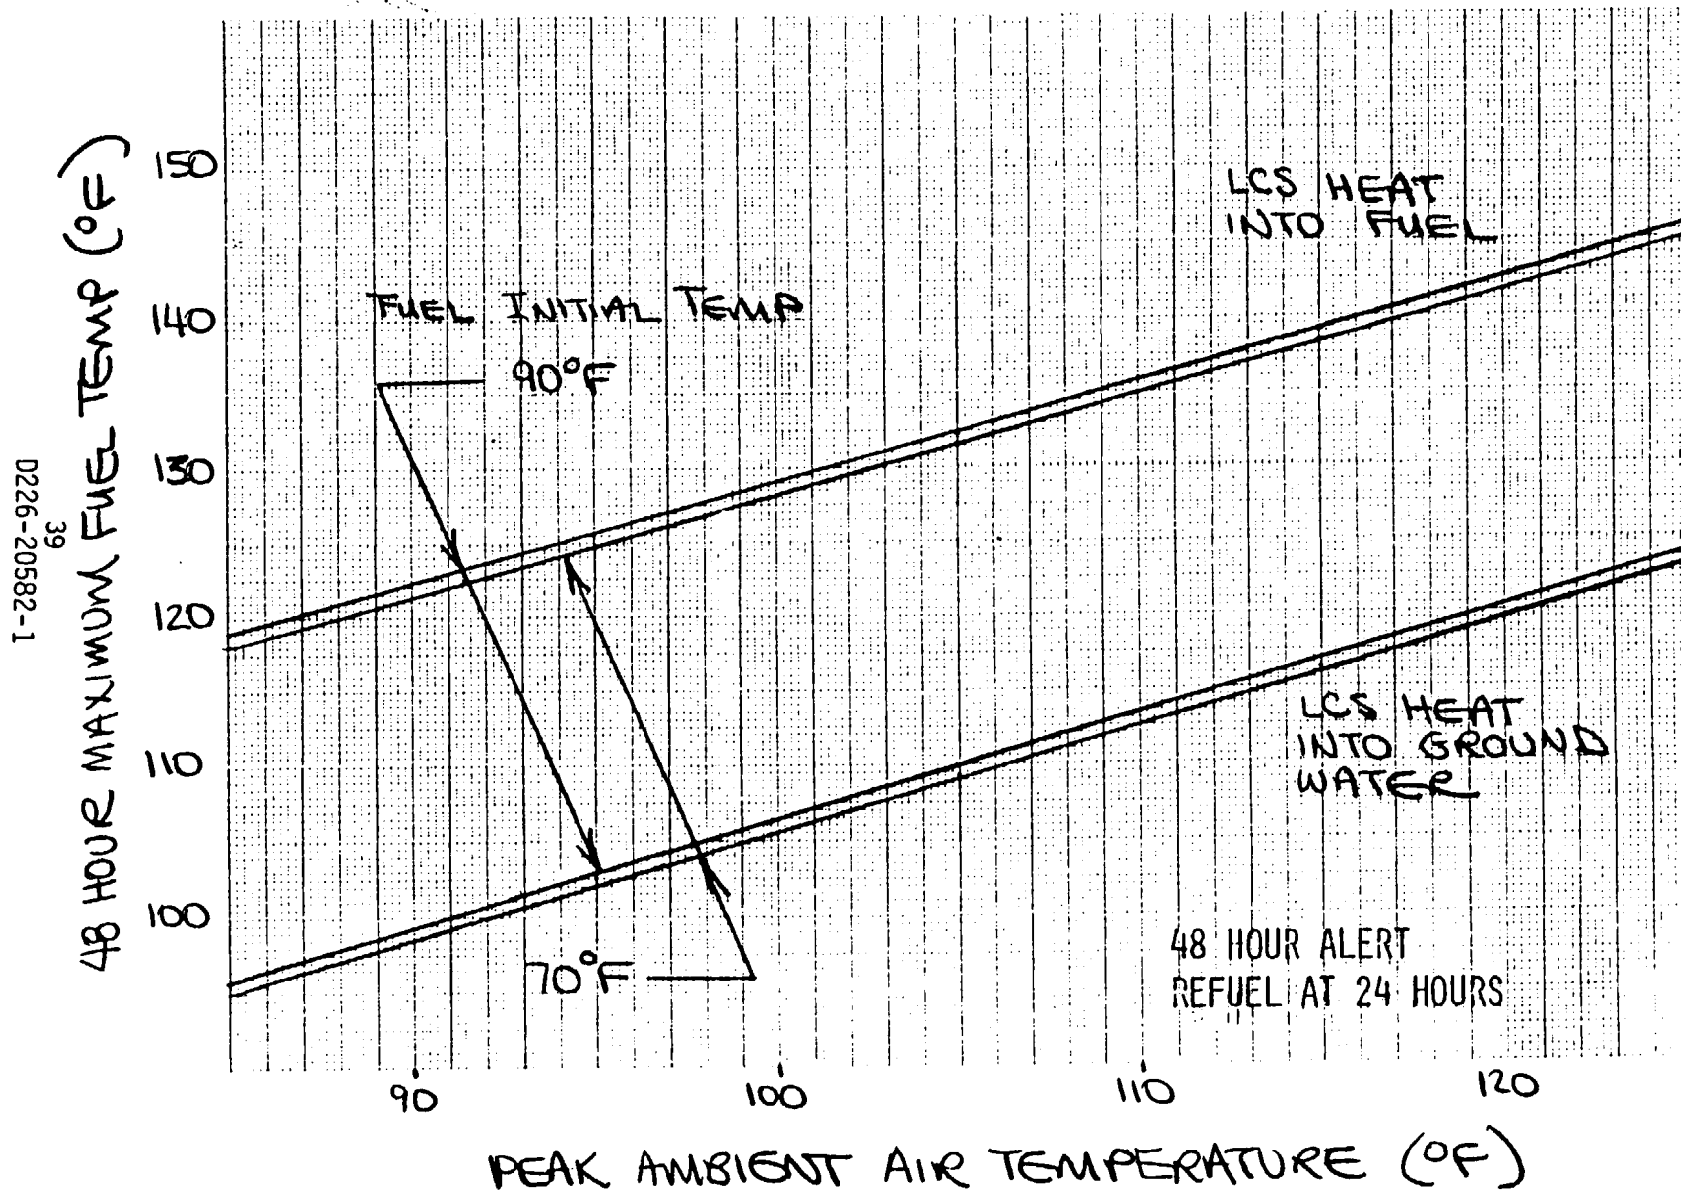
FIGURE 2.11

INITIAL FUEL TEMPERATURE EFFECT WING MAINS (2/3)

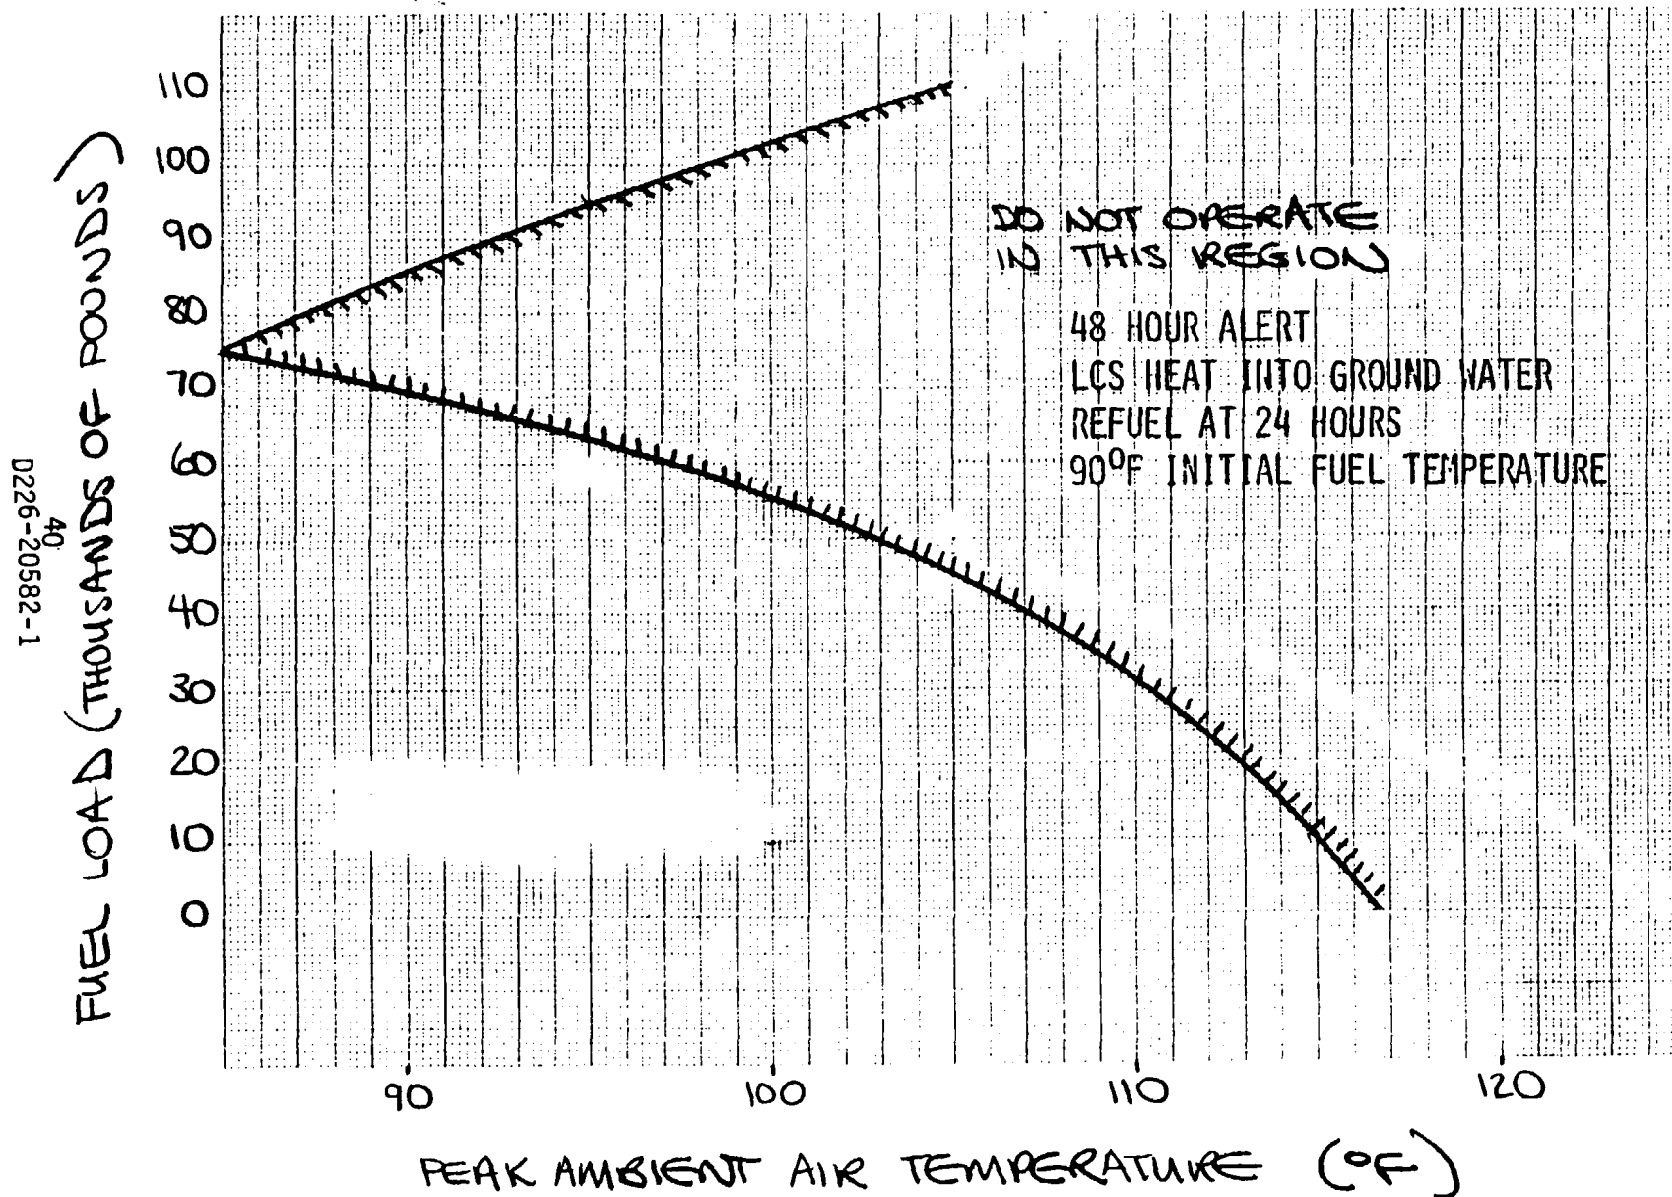
FIGURE 2.12

A study was conducted to define the allowable fuel load envelope. Figure 2.12 illustrates the result of this study. Small fuel loads can be burned off before the fuel reaches 130°F. Large fuel loads have sufficient mass to delay heating to temperatures above 130°F. However, as shown in the Figure, a considerable envelope exists within which acceptable operation is not possible.

CENTER WING FUEL TANK ALLOWABLE FUEL LOAD

- a) If the center wing tank is filled every 24 hours, and fuel is burned at a rate sufficient to power the APU and one engine:
 - 1) the LCS heat must be dissipated in the ground heat exchanger on all days for which the peak ambient air temperature exceeds 89°F.
 - 2) on all days for which the peak ambient air temperature exceeds 104°F, a full fuel load will result in temperatures in excess of 130°F.
- b) If the LCS heating is dissipated into ground water; the allowable fuel load restrictions of Figure 2.12 apply.
- c) If LCS heating is dissipated into the fuel tanks; the allowable fuel load restrictions are considerably more severe than depicted in Figure 2.12.

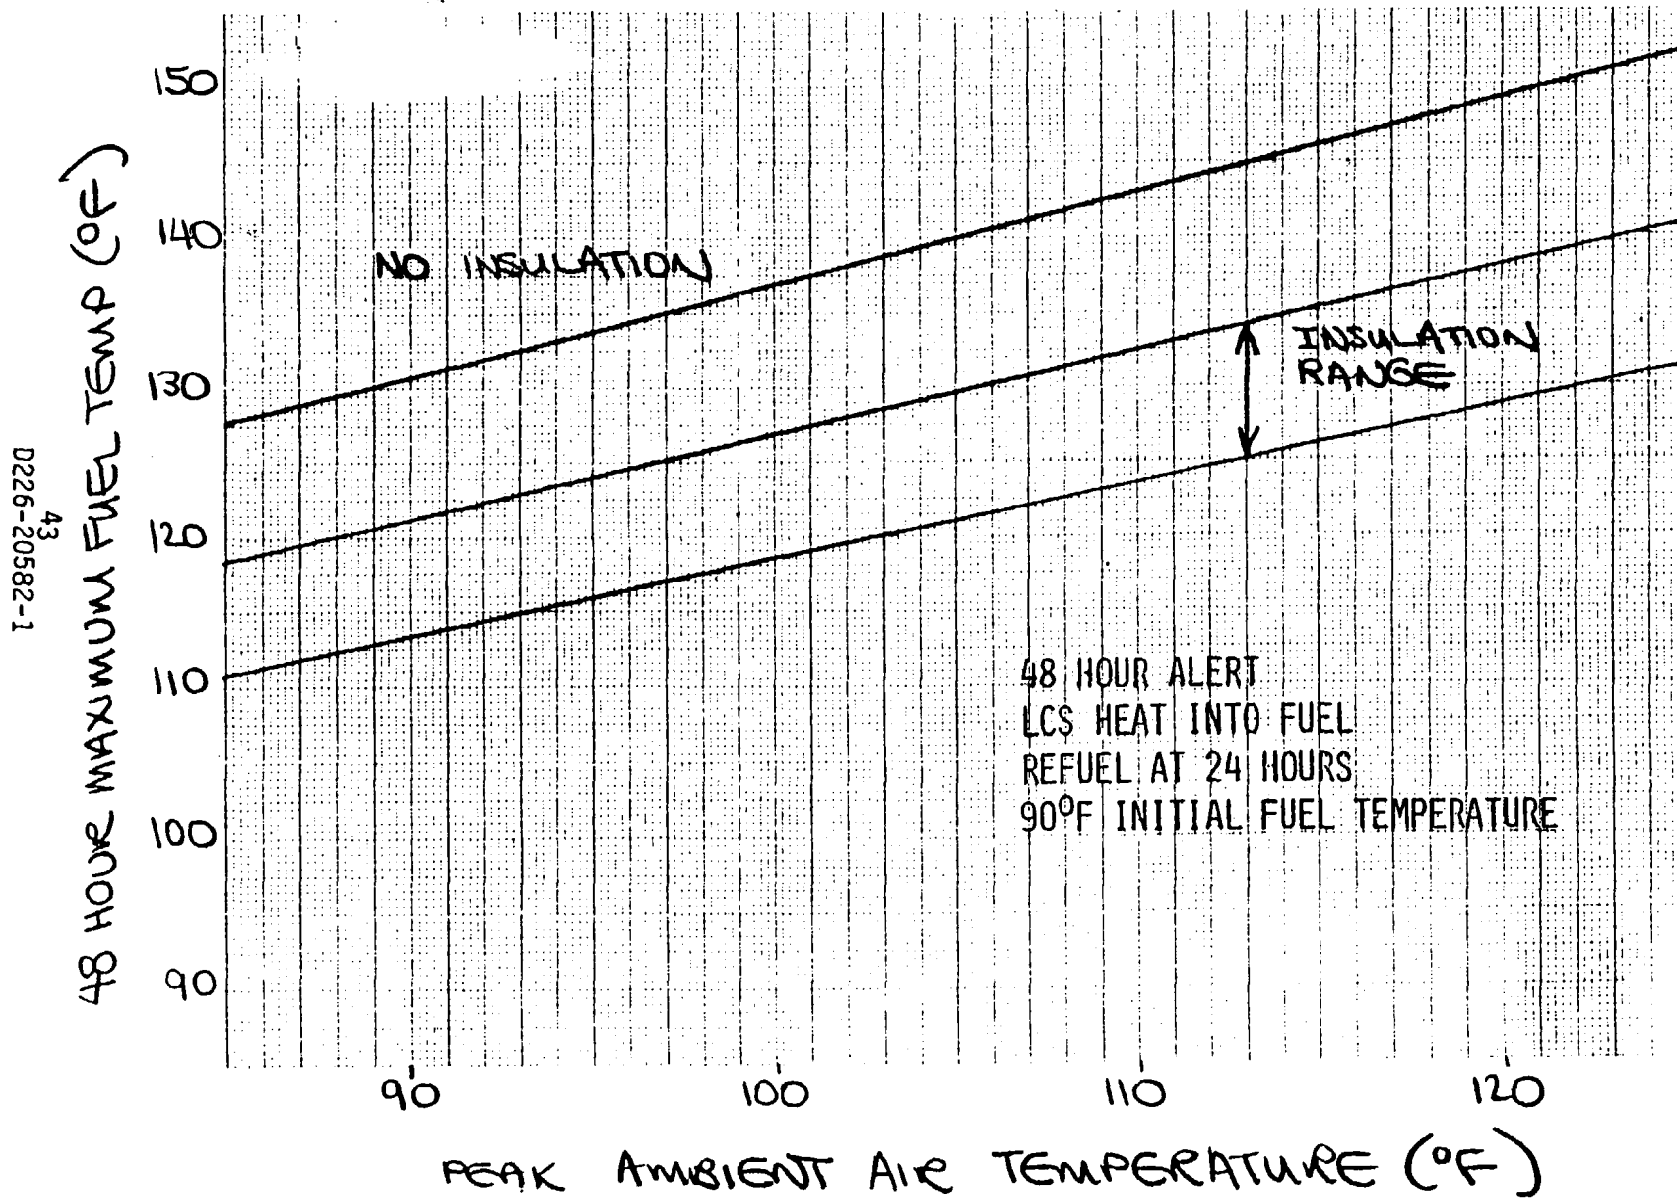
FIGURE 2.14

CENTER WING TANK FUEL TEMPERATURE
EFFECT OF INSULATION ADDITION

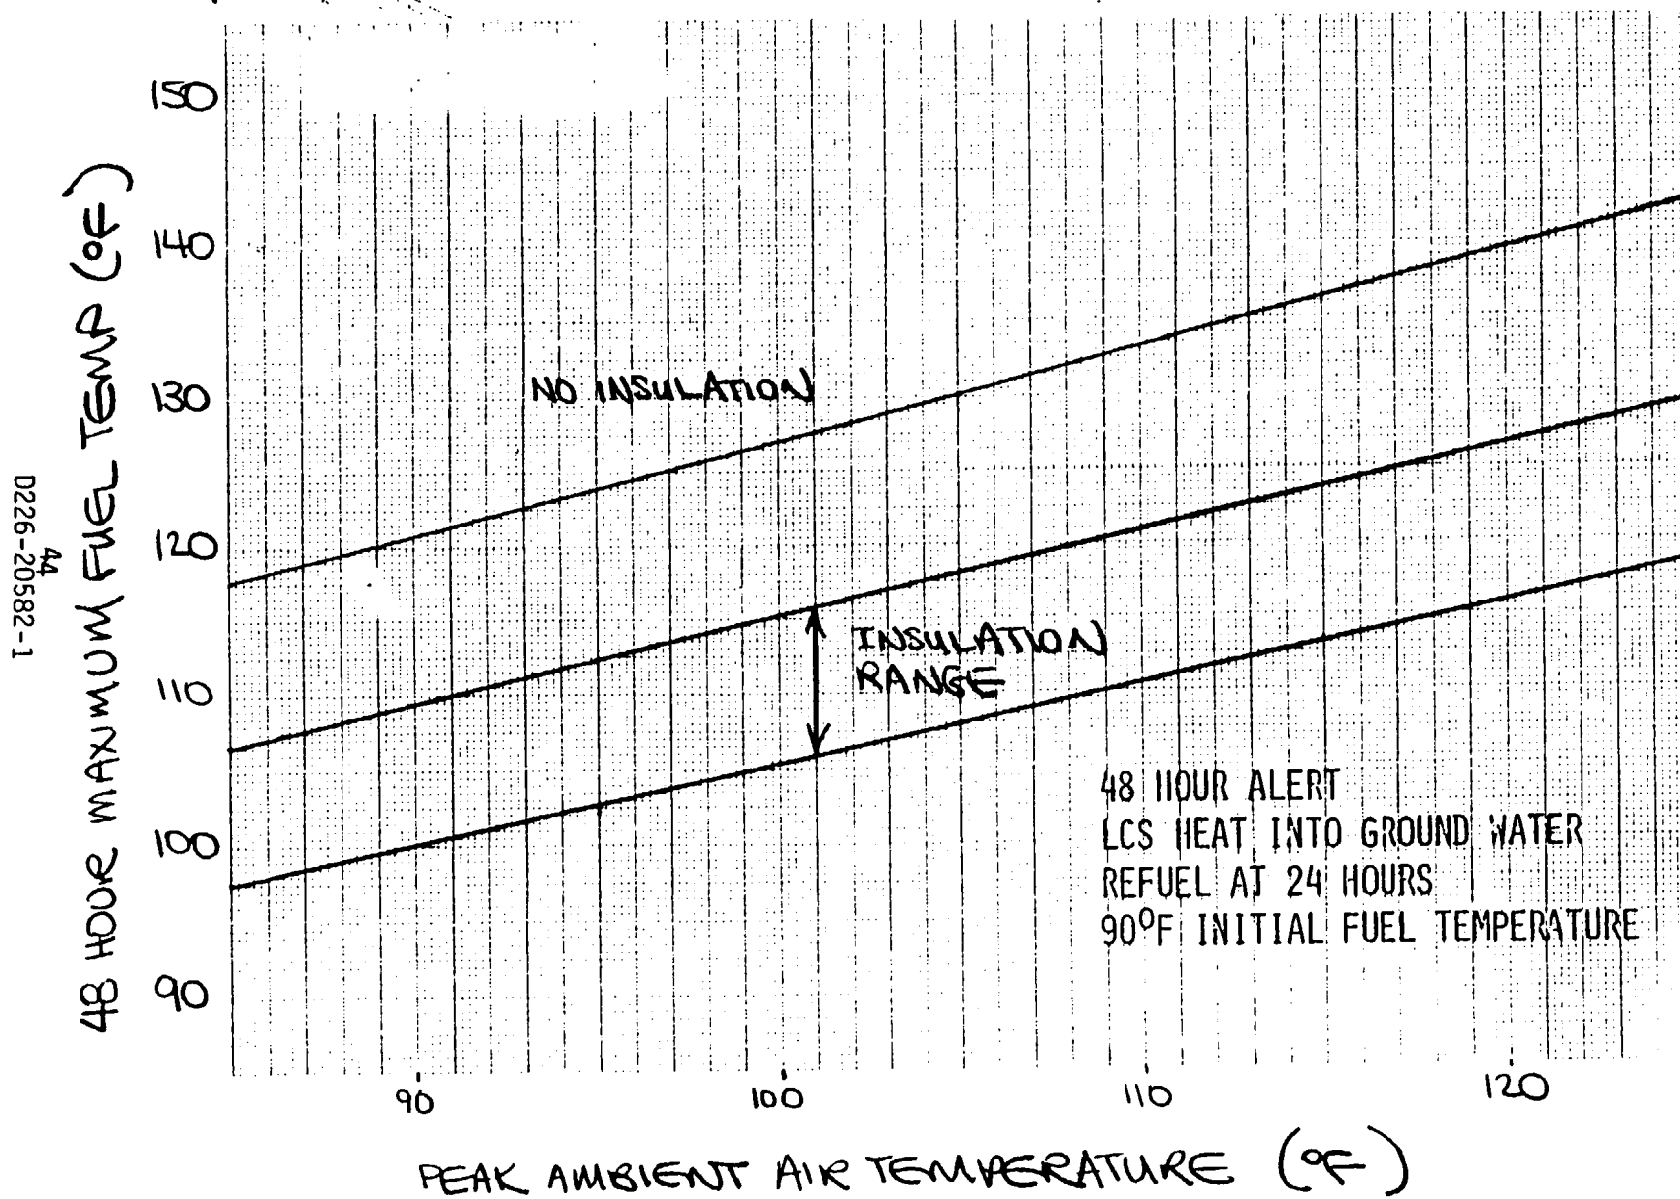
FIGURE 2.15

CENTER WING TANK FUEL TEMPERATURE EFFECT OF INSULATION ADDITION

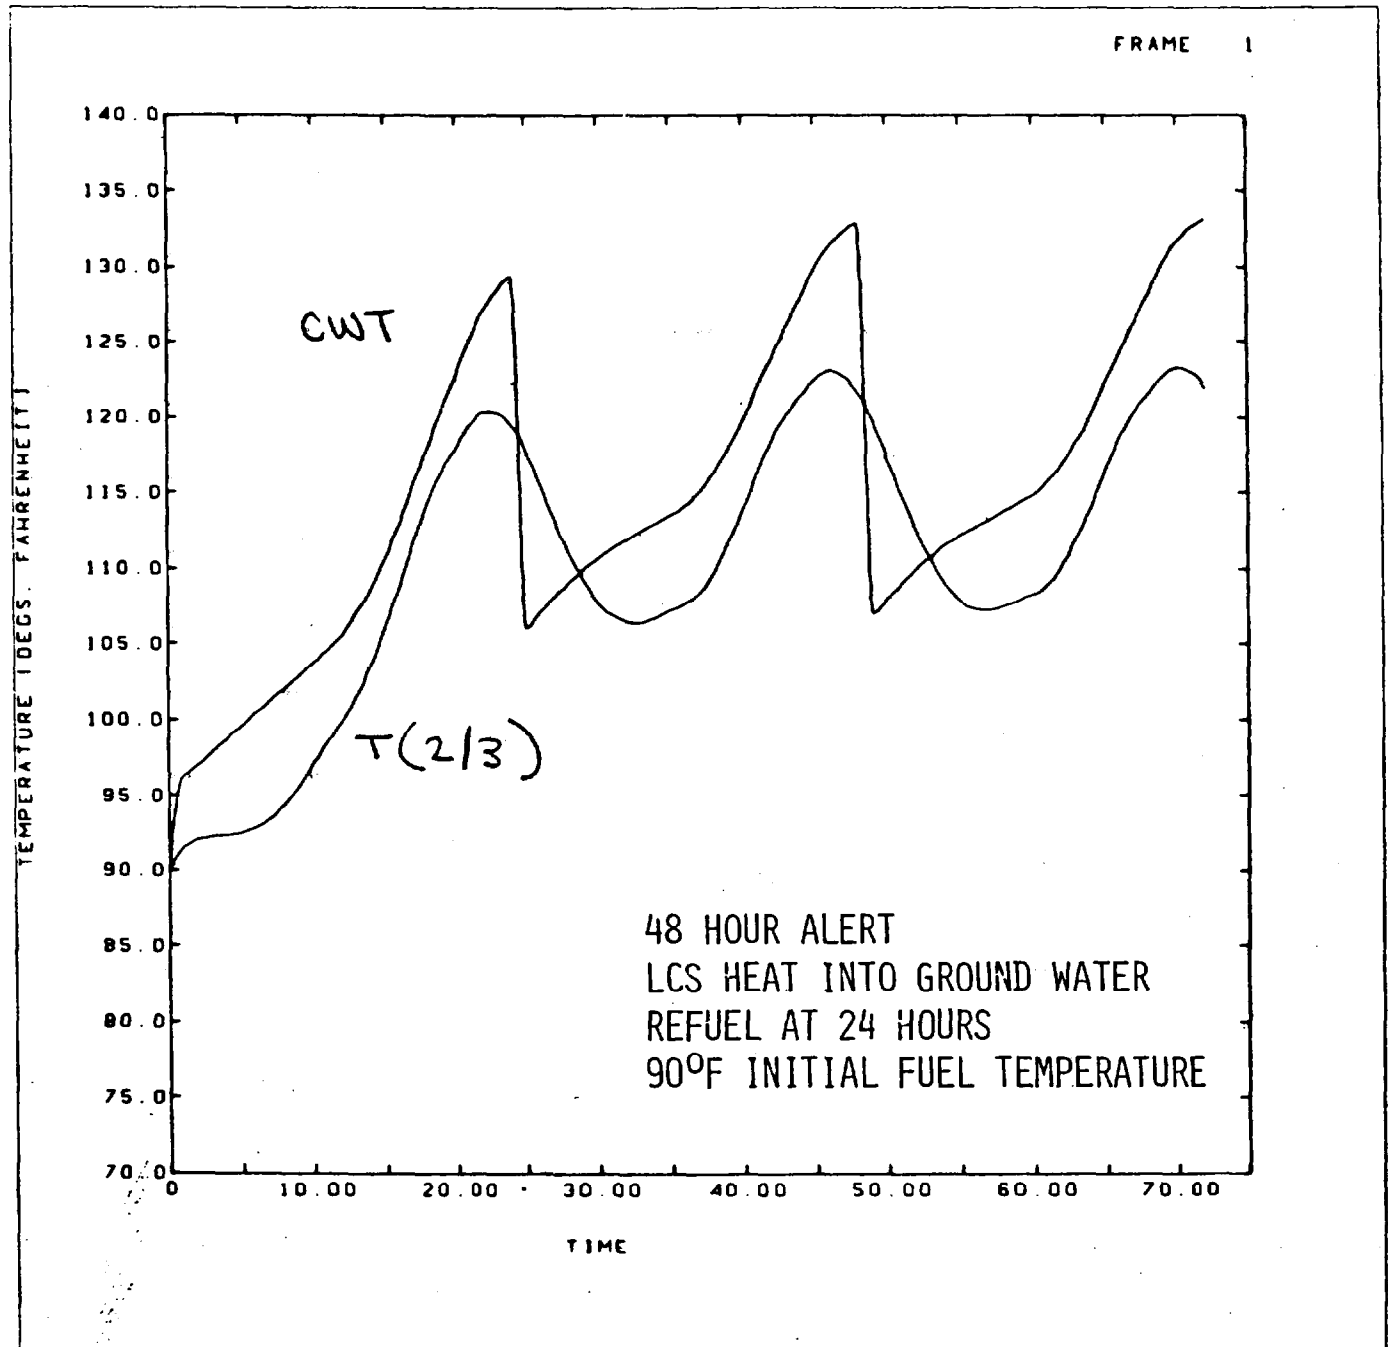
Figure 2.15.1

Fuel Temperature Variation with Time (125°F Peak Air Temperature)

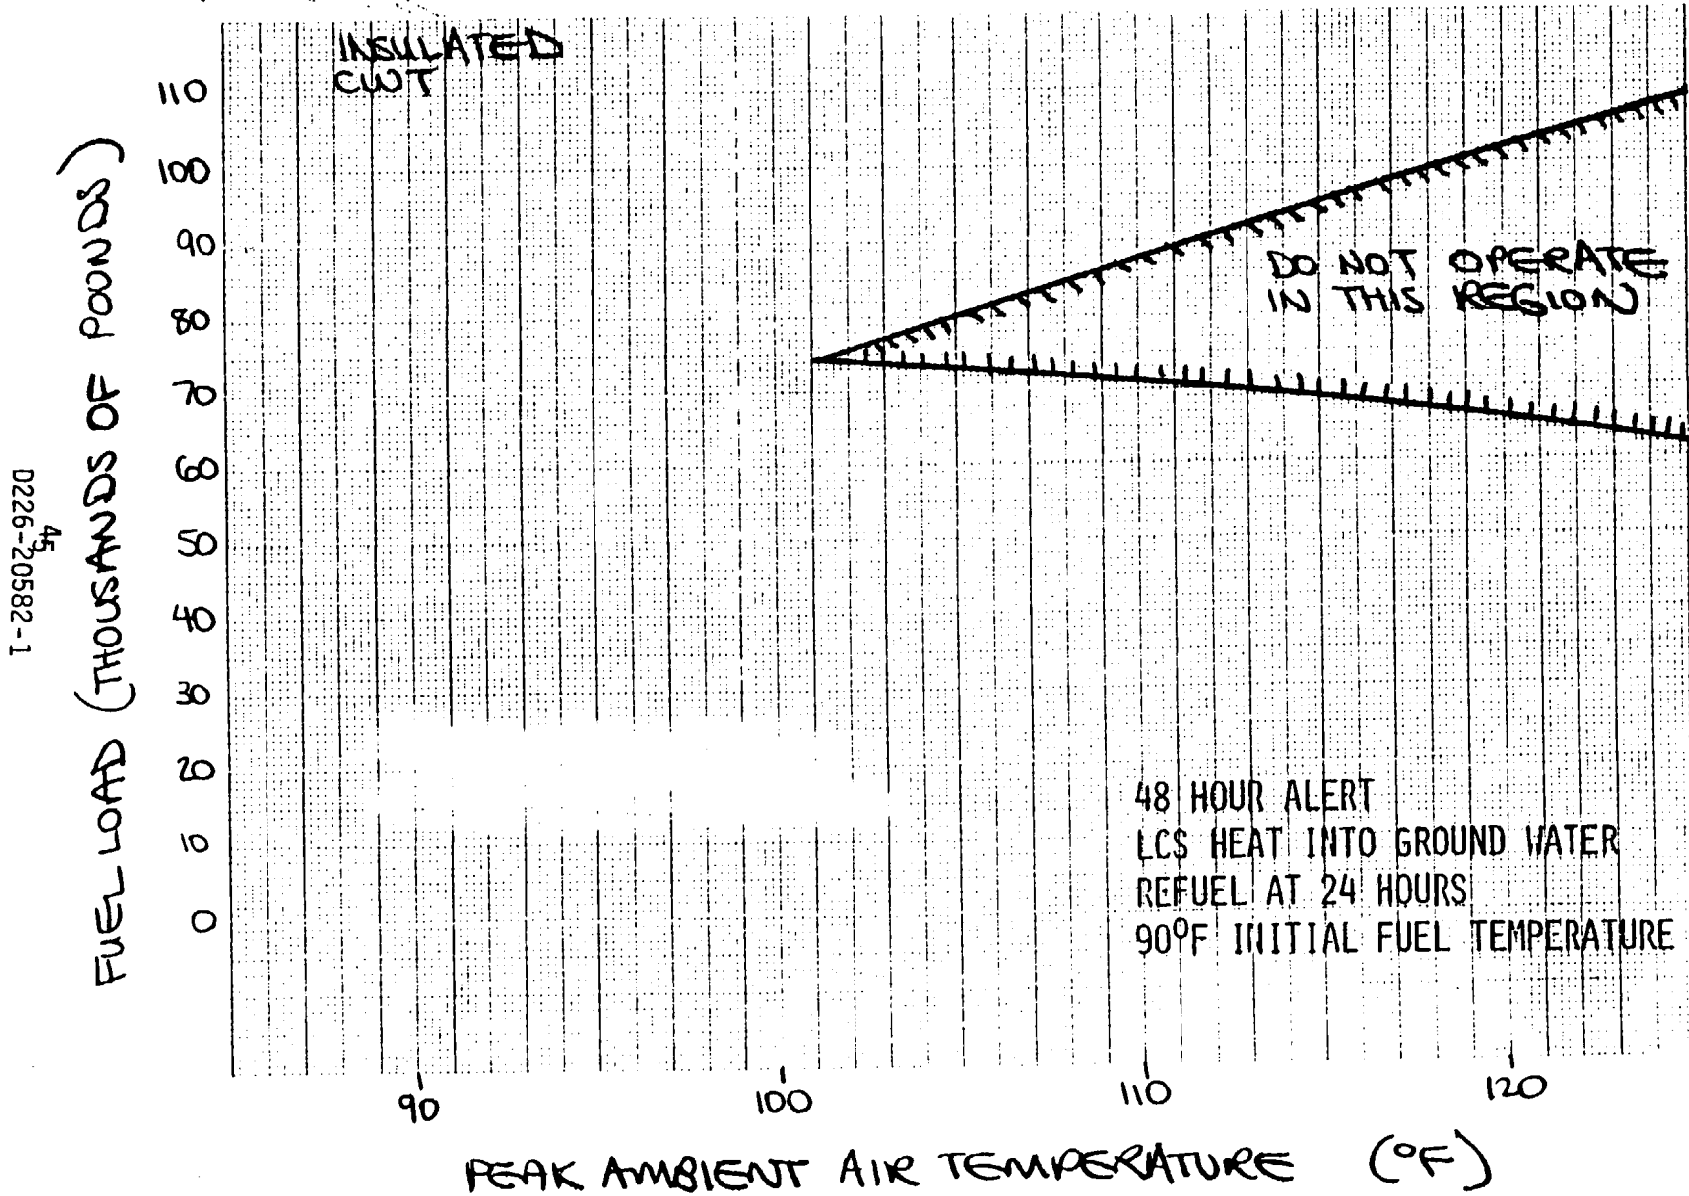
FIGURE 2.16

CENTER WING FUEL TANK ALLOWABLE FUEL LOAD
